1. STATE Maryland COUNTY Cecil

PRESENT USE Ruins WALL CONSTRUCTION Squared log grooved construction

HISTORIC AMERICAN BUILDINGS SURVEY INVENTORY CE - 36

Condition: RUINS

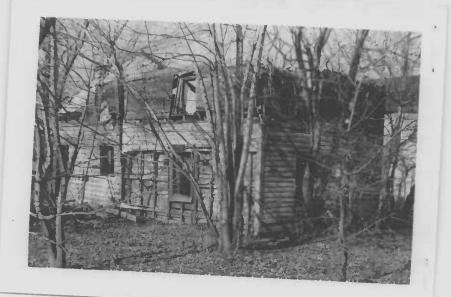
CECIL CTY # 36 (G.36 39 DG 12/67

This was a small log building two bayssquare and two stories in height which probably had an A-roof. (The roof is now completely gone.) This log dwelling was built into a slightly larger frame structure. The logs are square and laid in a grooved construction pattern, one on top of another. Many adze marks show on their surfaces. They are chinked between with plaster and fragments of broken brick.

This structure is important even in its ruinous state as ome of the few surviving log structures in this county. Its site should be noted since it seems to be beyond repair. It is also interesting because it is two stories in height even though it is such a tiny structure.
